**Flood Control Project Maintenance  
Levee Inspections**

## Maintenance Issue Types Only, Levee Inspection Report By Mile - Fall 2015

### Reclamation District No. 2095 Paradise Cut

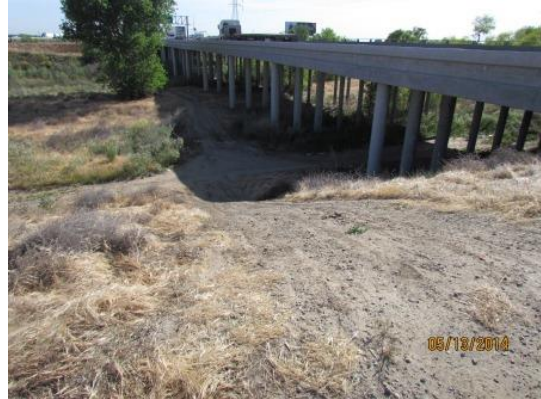
Photo 1 of 1 : FA\_2015\_RD2095\_322\_134\_20150910\_00008.jpg

View of the vehicle access on the waterside levee slope.

| Repair the levee slope damaged by vehicle traffic and prevent access where possible. | | | | | |

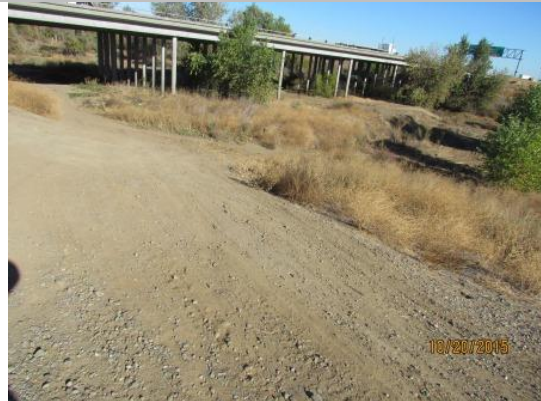
Photo 1 of 1 : FA\_2015\_RD2095\_322\_10\_20151026\_00014.jpg

View of the vehicle tracks on the waterside levee slope.

| Repair the levee slope damaged by vehicle traffic and prevent access where possible. | | | | | |

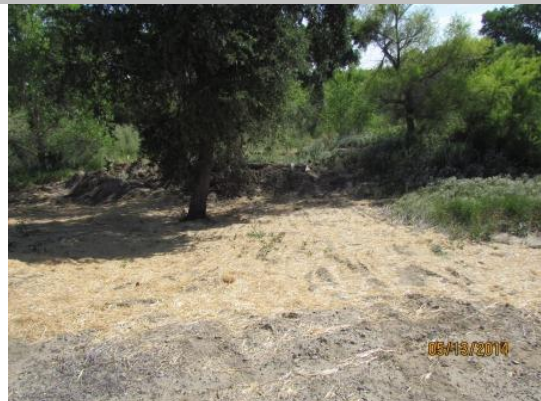
Photo 1 of 1 : FA\_2015\_RD2095\_322\_13\_20150910\_00007.jpg

| Inspector Comments: LMA is actively controlling the slope instability. | | | | | |

View of the repaired waterside levee slope.

| Repair the levee slope damaged by vehicle traffic and prevent access where possible. | | | | | |

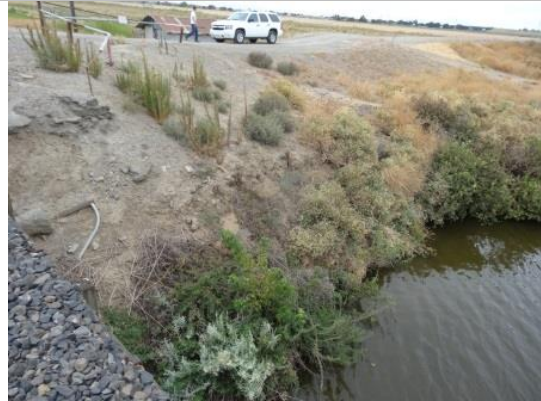
Photo 1 of 2 : SJR2015\_RD2095U01RM6.74\_14.jpg

| Inspector Comments: 08/04/2015: No significant change observed.<br>08/26/2014: No significant change observed.<br>08/28/2013: No significant change observed.<br>07/18/2012: No significant change observed.<br>09/02/2011: No significant change observed.<br>09/22/2010: No significant change observed. There is now considerable vegetation at the water line and along the lower berm slope. However, the erosion on the lower berm slope is still present and has not been corrected.<br>08/06/2010: Recommended for local maintenance issue, per CLRO.<br>07/29/2009: No major change since last visit; noticeable vegetation growth; erosion is on berm, but if left untreated, it will eventually erode into levee prism; site is recommended for annual assessment and monitoring of the site, per CLRO CES 2008 Report; Site # is the same as RM6.80,LM0.73; previously rated "U".<br>07/22/2008: Downstream of WPRR near siphon pipe & pump; sandy levee; visited by Jeff Van Gilder and LRO in 2008 for repair assessment; scouring downstream of RR crossing, possibly caused by eddy effects.<br>03/13/2007: Site visited on 03/13/2007. [2015 Site ID:RD2095U01RM6.74] | | | | | |

Close view of the erosion downstream of the RR bridge.

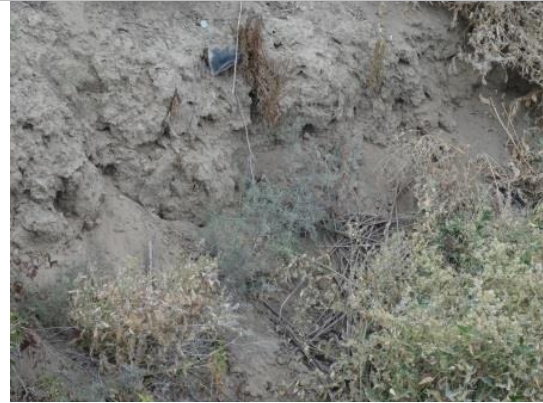
Photo 2 of 2 : SJR2015\_RD2095U01RM6.74\_9.jpg

Inspector Comments: 08/04/2015: No significant change observed.  
 08/26/2014: No significant change observed.  
 08/28/2013: No significant change observed.  
 07/18/2012: No significant change observed.  
 09/02/2011: No significant change observed.  
 09/22/2010: No significant change observed. There is now considerable vegetation at the water line and along the lower berm slope. However, the erosion on the lower berm slope is still present and has not been corrected.  
 08/06/2010: Recommended for local maintenance issue, per CLRO.  
 07/29/2009: No major change since last visit; noticeable vegetation growth; erosion is on berm, but if left untreated, it will eventually erode into levee prism; site is recommended for annual assessment and monitoring of the site, per CLRO CES 2008 Report; Site # is the same as RM6.80, LM0.73; previously rated "U".  
 07/22/2008: Downstream of WPRR near siphon pipe & pump; sandy levee; visited by Jeff Van Gilder and LRO in 2008 for repair assessment; scouring downstream of RR crossing, possibly caused by eddy effects.

Close view of the erosion.

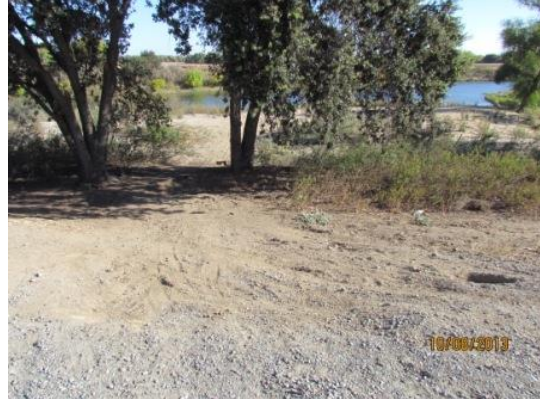
Photo 1 of 1 : FA\_2015\_RD2095\_323\_9\_20150910\_00006.jpg

View of the vehicle tire ruts on waterside levee slope.

| Repair the levee slope damaged by vehicle traffic and prevent access where possible. | | | | | |

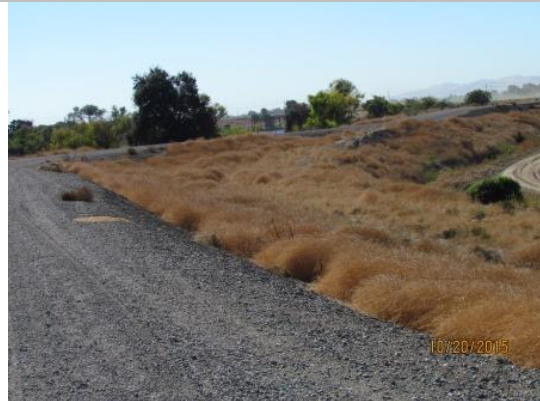
Photo 1 of 1 : FA\_2015\_RD2095\_323\_16\_20151026\_00014.jpg

View of the tall vegetation on the landside levee slope.

| Control annual grass and weeds on the levee slopes and easements.<br>Inspector Comments: The LMA removed the vegetation from the landside levee slope. | | | | | |

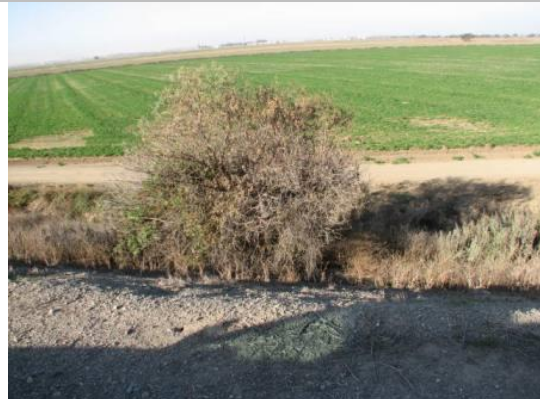
Photo 1 of 1 : FA\_2015\_RD2095\_323\_6\_20150910\_00005.jpg

| Elderberries are blocking visibility and flood fight capability. | | | | | |

11/01/2011 Elderberry bush at landside toe.

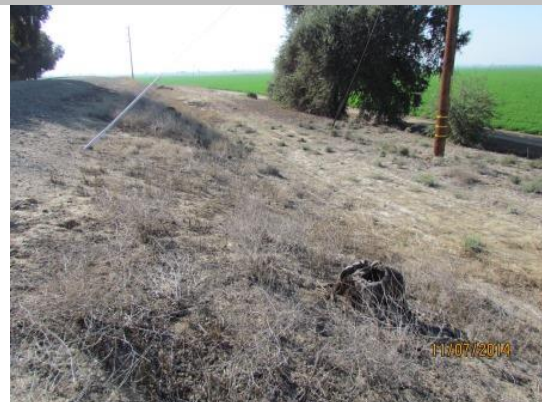
Photo 1 of 1 : FA\_2015\_RD2095\_323\_3\_20150910\_00003.jpg

| Tree stumps. | | | | | |
| Inspector Comments: 4 stumps | | | | | |

View of the tree stumps on the landside levee slope..

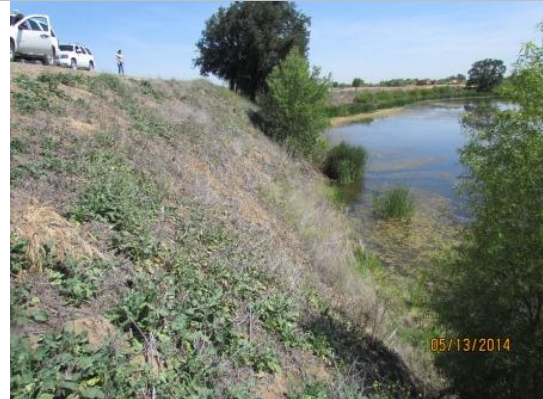
Photo 1 of 1 : FA\_2015\_RD2095\_323\_195\_20150910\_00009.jpg

View of the erosion on the waterside levee slope possibly eroding into the levee prism.

| Note and monitor erosion site. | | | | | |

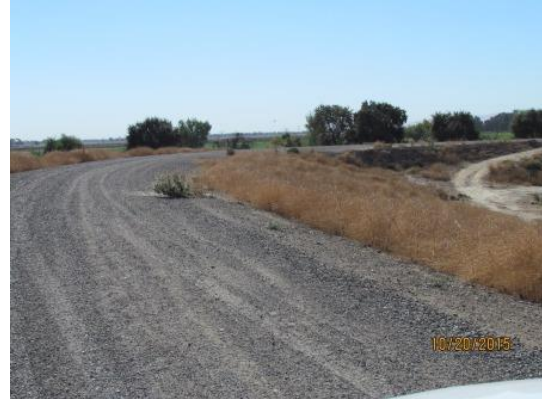
Photo 1 of 1 : FA\_2015\_RD2095\_323\_18\_20151026\_00016.jpg

View of the tall vegetation on the landside levee slope.

| Control annual grass and weeds on the levee slopes and easements. | | | | | |

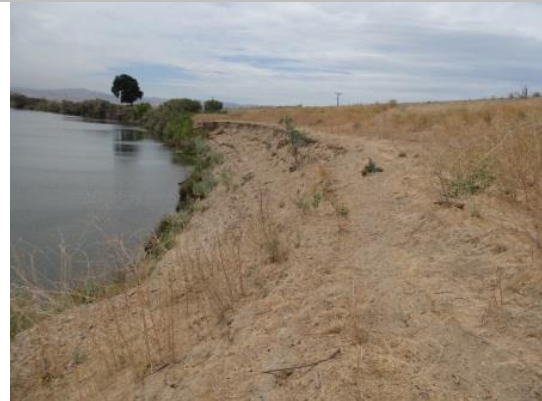
Photo 1 of 3 : SJR2015\_RD2095U02RM60.62\_12.jpg

| Inspector Comments: 08/04/2015: No significant change observed.<br>7/02/2014: No significant change observed.<br>08/28/2013: No significant change observed.<br>09/13/2012: The site has been visited by land survey. The vegetation on the site shows the erosion has not developed significantly from the last survey.<br>The site was not visited by boat survey due to the limitation of navigable waterway.<br>08/23/2011: No significant change observed.<br>9/22/2010: No significant change observed. There is moderate vegetation growth on the berm. Despite the erosion occurring on the berm, corrective action should be taken before the issue becomes severe.<br>9/29/2009: Site is immediately downstream of a section of existing rip rap; there is a 20-foot berm remaining; berm will continue to erode unless erosion is mitigated; Site# is the same as RM62.6, LM1.87; recommended for annual assessment, per CES Evaluation 2008 Report 2006: Visited 10/20/06 [2015 Site ID:RD2095U02RM60.62] | | | | | |

Close view of the site.

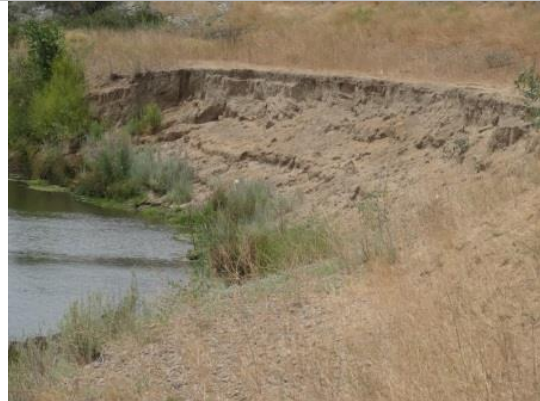
Photo 2 of 3 : SJR2015\_RD2095U02RM60.62\_13.jpg

Inspector Comments: 08/04/2015: No significant change observed.  
 7/02/2014: No significant change observed.  
 08/28/2013: No significant change observed.  
 09/13/2012: The site has been visited by land survey. The vegetation on the site shows the erosion has not developed significantly from the last survey.  
 The site was not visited by boat survey due to the limitation of navigable waterway.  
 08/23/2011: No significant change observed.  
 9/22/2010: No significant change observed. There is moderate vegetation growth on the berm. Despite the erosion occurring on the berm, corrective action should be taken before the issue becomes severe.  
 9/29/2009: Site is immediately downstream of a section of existing rip rap; there is a 20-foot berm remaining; berm will continue to erode unless erosion is mitigated; Site# is the same as RM62.6, LM1.87; recommended for annual assessment, per CES Evaluation 2008 Report 2006: Visited 10/20/06 [2015 Site ID:RD2095U02RM60.62]

View of the erosion.

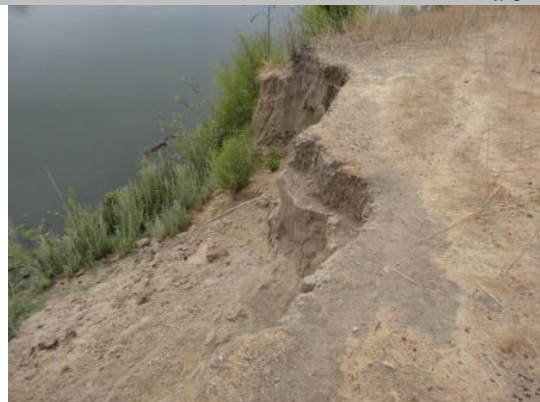
Photo 3 of 3 : SJR2015\_RD2095U02RM60.62\_4.jpg

Close view of the site.
